OPERATING EXPERIENCE WEEKLY SUMMARY

Office of Nuclear and Facility Safety

February 19 - February 25, 1999

Summary 99-08

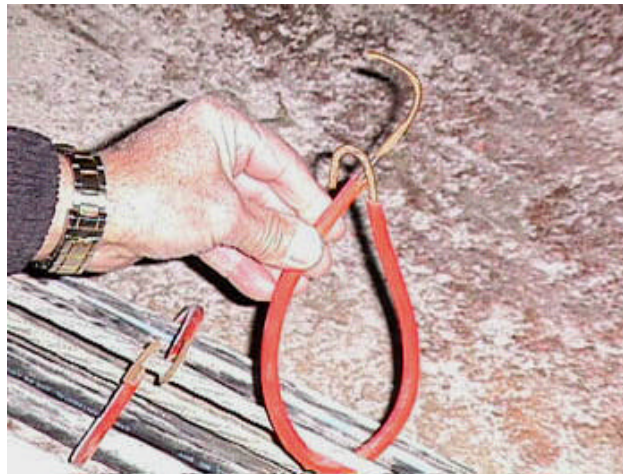
Investigators estimated that the cables weighed approximately 15 to 20 pounds per foot and that they fell approximately 15 feet. They determined that the three-man crew relied on skill-of-the-craft to safely relocate the cables. The permanent support system consisted of a steel cable suspended from the roof of the underground. The cable hangers, referred to as spring clips, encircled the cable bundles at engineered intervals and the ends of the spring clips were hooked over the steel cable. The crew unhooked both ends of each spring clip from the permanent steel cable and relocated each clip by hooking only one end of it onto nearby rock bolt plates. The weight of the cables was sufficient to straighten the end of the spring clips, and the cables fell. The facility manager suspended work in the area, appointed a root cause investigation team, and ordered that the fallen cables be reattached to the permanent support system. Figure 1-1 shows one of the failed spring clips.

Figure 1-1. Failed Spring Clip

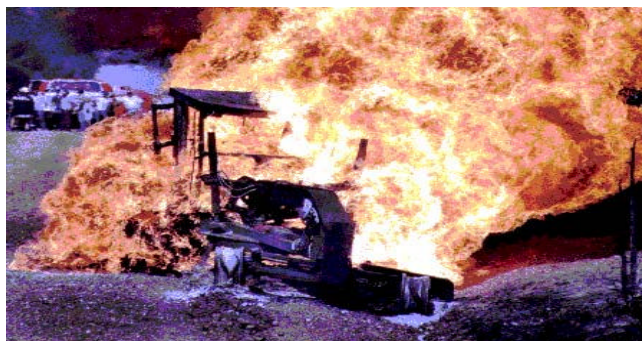
Natural gas explosions can cause significant damage and loss of life. On December 11, 1998, in St. Cloud, Minnesota, workers attempting to lay a fiber optic cable cut a gas main, resulting in an explosion. The blast leveled three buildings, killed 4 people, and injured 10 others. Bureau of Labor Statistics data on construction-related occupational injuries show that in 1996, 50 fatalities were attributable to excavation work. Figure 2-1 shows a 1989 event at Lebanon, Missouri, in which an operator was killed when his road grader struck a 10-inch propane pipeline.

Figure 2-1. Propane Line Severed¹

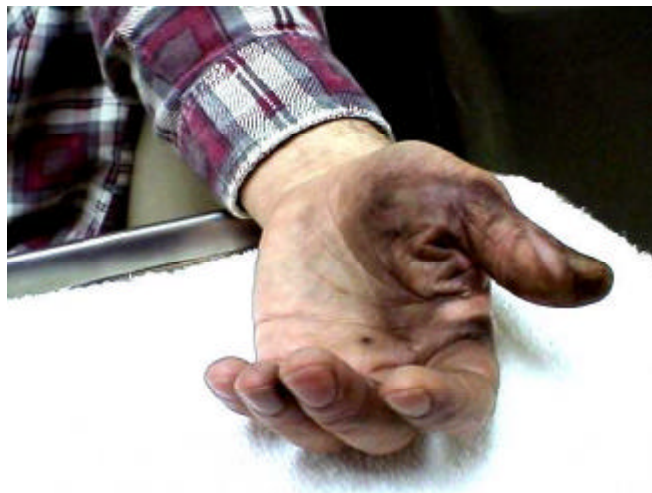
Investigators determined that the electrician was using a generic work order to troubleshoot intermittent power losses and that the work order did not require him to lock out or tag out the power strip. He had traced the problem to two receptacles in the office partition and was attempting to measure the voltage. He turned slightly to look at the voltmeter and accidentally moved the test probes, causing the short circuit. The power strip connector contacts are approximately one-eighth of an inch apart. Investigators also determined that the low voltage electrical standard operating procedure requires workers to wear safety glasses during troubleshooting activities. However, it permits workers to forego wearing insulated gloves if they determine gloves hinder their manual dexterity. Figure 4-1 shows the burns on the electrician's left hand.

Figure 4-1. Burns on Electrician's Left Hand

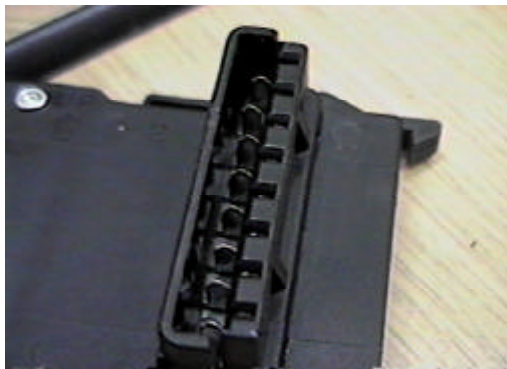
Figure 4-2. Undamaged Power Strip Connector Contacts

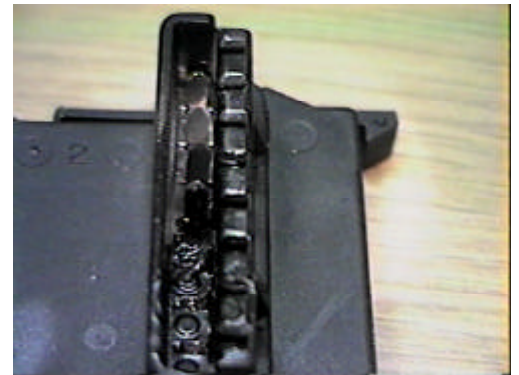
Investigators determined that the power strip was not insulated between the connector contacts so the power strips from adjoining office partitions could be plugged together. Investigators also determined that the manufacturer recommends that when defects are suspected in the power strips, resistance testing should be performed instead of voltage testing. The manufacturer also recommends that the strips be de-energized before any testing or work is performed on them. Facility personnel were unaware of these recommendations until after the short circuit.

Figure 4-3. Damaged Power Strip Connector Contacts
